Aviation Research and Analysis Report – AR-2009-033

**Factors influencing misaligned take-off
occurrences at night**

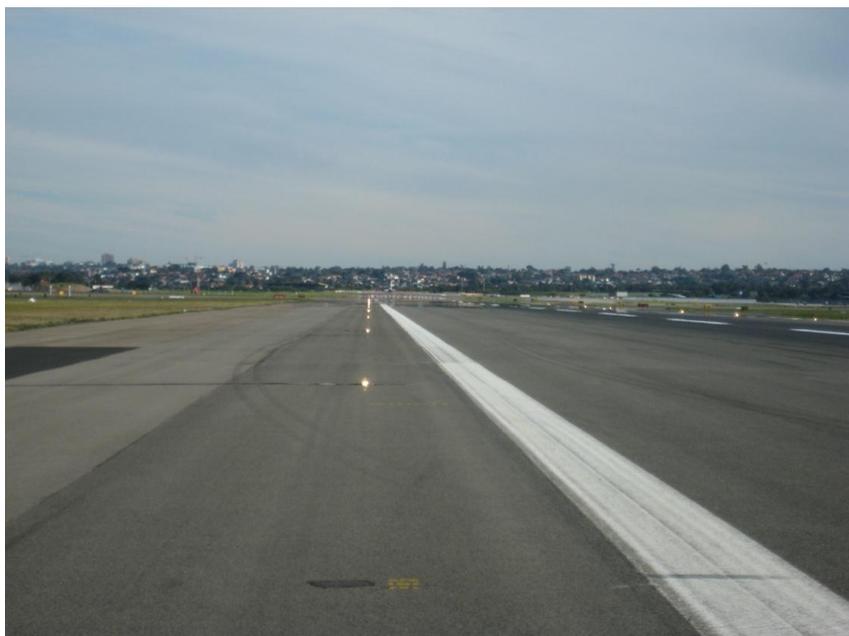
On the night of 3 July 2009, the crew of a SAAB 340B aircraft, registered VH-ZLW, was preparing to take off at Sydney Kingsford Smith Airport, New South Wales (NSW), on a scheduled passenger service to Lismore, NSW. The aircraft was taxied onto the runway 25 from the right and lined up with the left edge runway lights for takeoff (Figure 1). Runway 25 does not have centreline lighting.

Figure 1: Extra pavement/runway width runway 25 Sydney (looking in the direction of takeoff)

Various factors were identified that influenced the initial misalignment for takeoff:

- the runway did not have centreline lighting, but had recessed edge lights
- the runway had extra tarmac width at the point where the aircraft entered the runway for an intersection departure (Figure 1)
- the crew were completing the line up checklist and controls check on the runway as the aircraft's gust locks were in place while holding on the taxiway due to strong winds, resulting in both crew having their eyes mostly inside the cockpit
- the first officer had poor vision of the runway from his seat position.

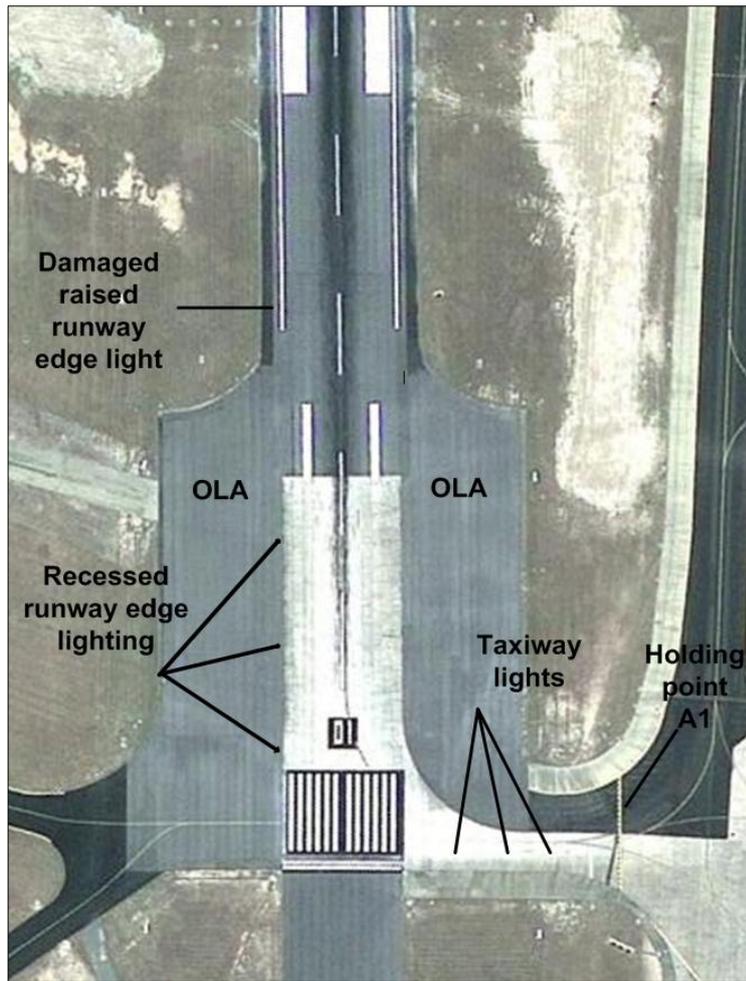
On 11 February 2009, the crew of a Bombardier Dash-8-315 (Dash-8) aircraft, registered VH-SBW, was preparing for takeoff at Townsville, Queensland (Qld) for a scheduled passenger service to Cairns, Qld. In dark and raining conditions, the aircraft entered runway 01 from the right from holding point A1 and was lined up with the left edge runway lights for takeoff (Figure 2).

Figure 2: Aerial view of Townsville Airport and Runway 01

The investigation is continuing and is considering various factors, including:

- the reduced visibility due to rain
- the additional area of tarmac in the area where the aircraft entered the runway (Figure 2)
- flight crew workload and distractions relating to time pressure and delays throughout the day, and attention given to monitoring the prevailing weather.

In addition, the runway edge lights were recessed at the point where the aircraft lined up on the runway, which may have provided the crew with the impression that they were lined up on the centreline lights.

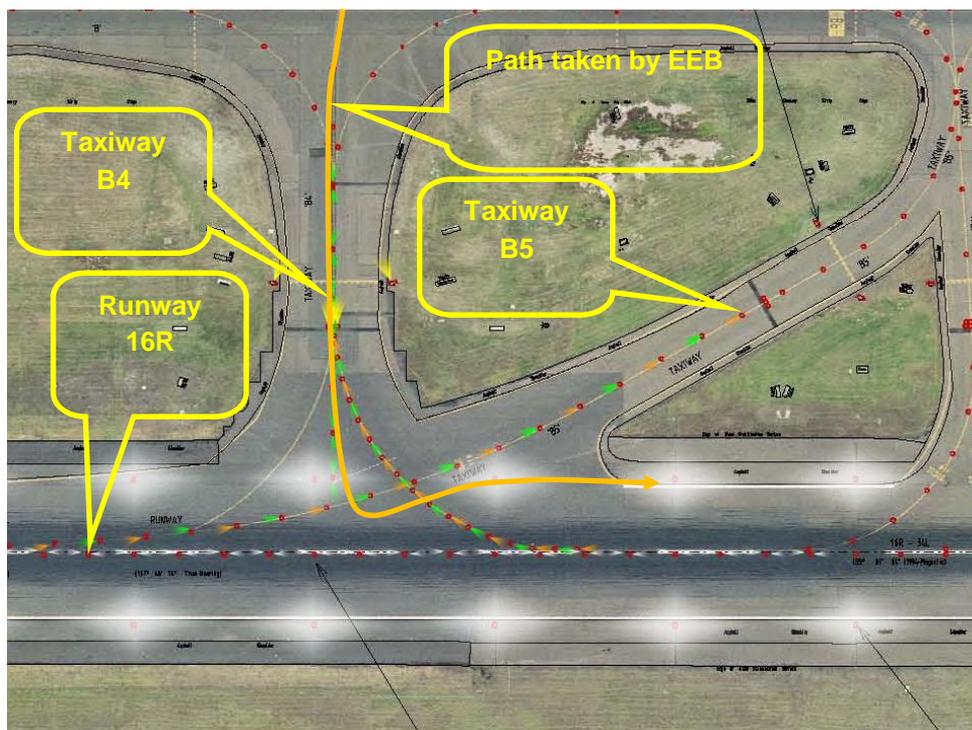
and then lined up with the left edge lighting prior to commencing the takeoff (Figure 3).

Pre-flight checks in Melbourne for the return flight to Sydney revealed damage to the aircraft, which was subsequently found to have been caused by impact with the runway 16R left edge lighting at Sydney.

Figure 3: An overhead photograph depicting runway and taxiway lighting in the area near runway 16R, taxiway B4, taxiway B5 and the path taken by EEB.

The investigation identified various contributing safety factors to the initial misalignment on the runway included the layout of the runway, specifically

- The taxiway B4 left edge marking led onto taxiway B5, instead of runway 16R
- the runway markings leading to taxiway B5
- the absence of runway edge markings at the intersection
- the additional area of tarmac surrounding the area in which the aircraft entered the runway.

In combination with reduced visual cues associated with night operations, these factors probably created the impression that the aircraft had proceeded further into the runway than it actually had.

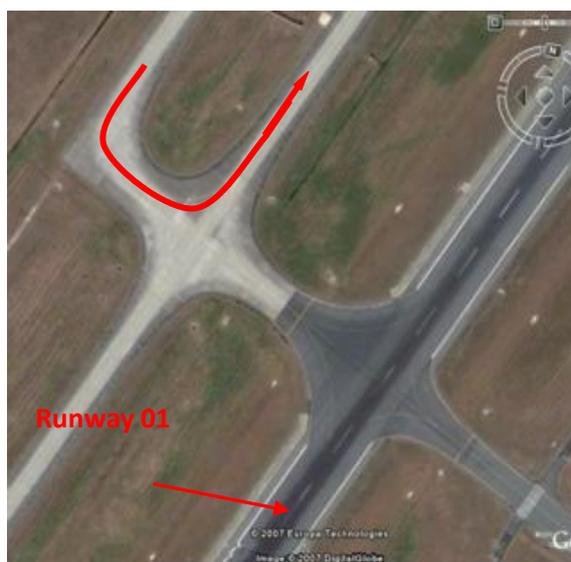
On the night of 25 November 2007, a Gulfstream Aerospace Corp G-IV aircraft, registered HB-IKR, was being operated on a passenger charter flight between Brisbane, Qld and Sydney, NSW. The captain inadvertently commenced the takeoff from a taxiway parallel to the runway in use. Air traffic control realised the aircraft was on a taxiway and cancelled the take-off clearance. The aircraft was stopped on the taxiway and manoeuvred to the runway for the subsequent takeoff. The flight proceeded to Sydney without further incident.

Figure 4: Overhead view of intersection² with aircraft track highlighted

The investigation identified various factors which contributed to the attempted takeoff on the taxiway, including:

- the captain did not use the available means to assist in guiding the aircraft during taxi after his electronic flight bag display became unserviceable;
- communication between the flight crew was adversely affected by a steep trans-cockpit authority gradient
- the limited rest and jetlag of the captain
- the takeoff being conducted via an intersection departure from taxiway A7, which did not have normal runway threshold markings
- increased workload for the captain and possible self-imposed time pressure.

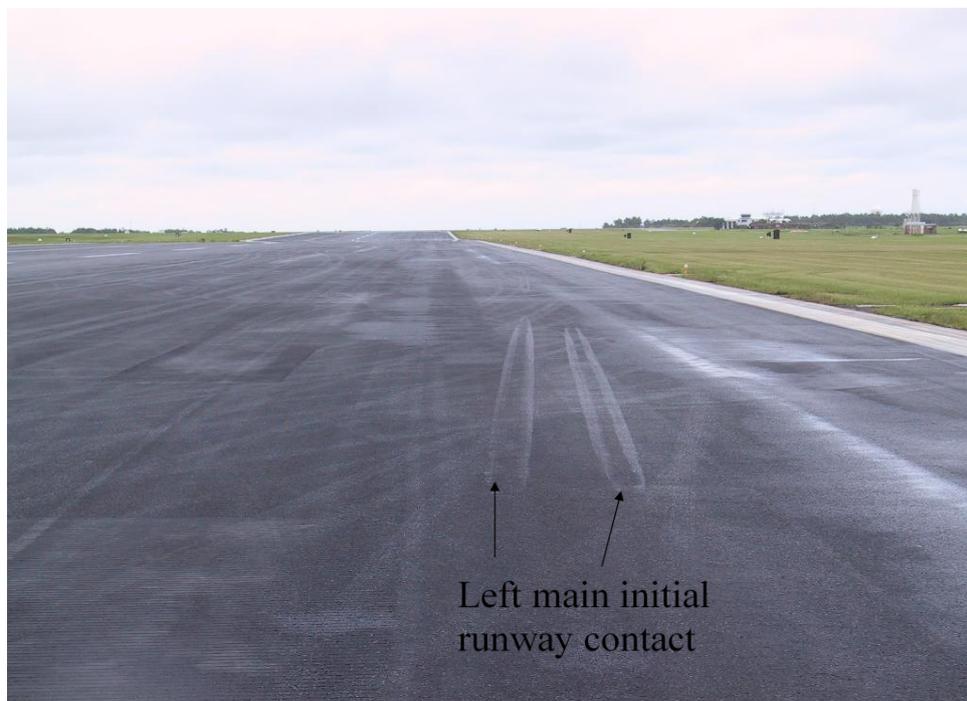
On 19 February 2003, a Boeing Company 737-376 aircraft, registered VH-TJB, was being operated on a scheduled passenger service from Adelaide, South Australia (SA) to Darwin, Northern Territory (NT). During the landing on runway 29, the aircraft touched down close to the right edge of the runway and ran off the sealed runway surface. The aircraft was returned to the runway during the landing roll. There were no injuries to crew or passengers, but the aircraft sustained minor damage.

The approach was conducted at night and in conditions of reduced visibility due to heavy rain, with the windscreen wipers set to 'high'. Immediately after touchdown, the captain saw that the runway edge lights were tracking down the windscreen centre frame and heard the aircraft wheels strike runway lights.

Figure 7: Lateral touchdown position of the left main landing gear

The investigation identified several factors which reduced the captain's ability to detect the aircraft's displacement from the runway centreline. These included:

- painted runway markings that were less conspicuous on a wet runway at night;
- a lack of touchdown zone lighting/centreline lighting on a runway that was wider than the standard runway width; and
- the possibility that the High Intensity Runway Lighting was glaring on the wet windscreen.
