ATSB TRANSPORT SAFETY REPORT
Aviation Research and Analysis Report – AR-2009-052

Take-off performance calculation and entry errors:

A global perspective

AR-2009-052

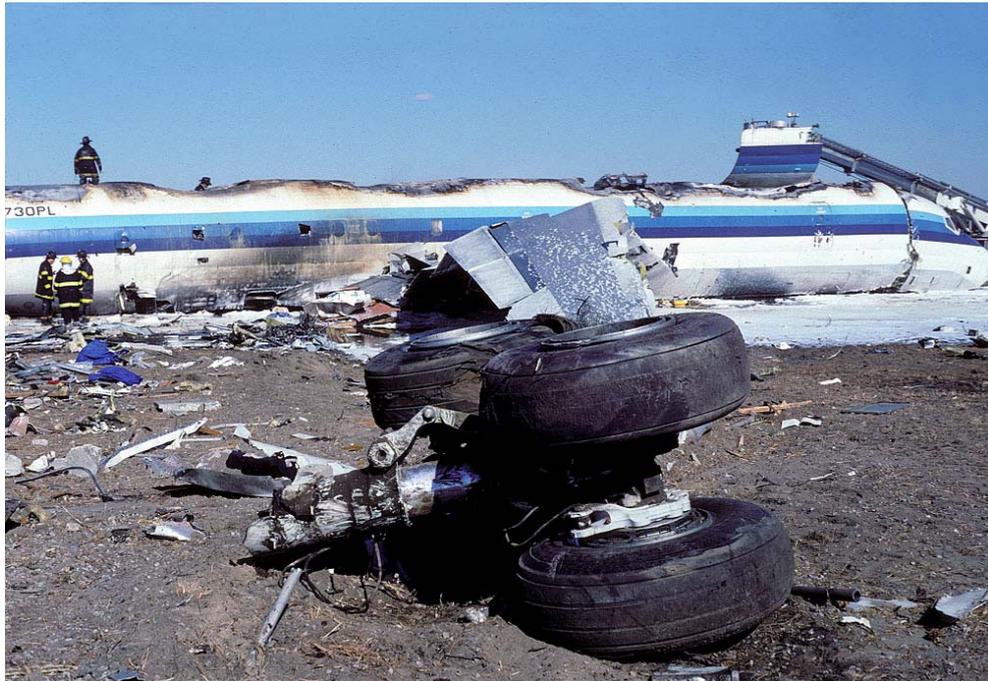
Figure 8: N730PL accident

- The flight engineer calculated the take-off performance data based on a take-off weight (TOW) of 242,000 lbs (109,771 kg) instead of 342,000 lbs (155,131 kg).
- Shortcomings were identified in the airlines crew training program, and questionable scheduling of qualified, but marginally experienced crew for the accident flight.

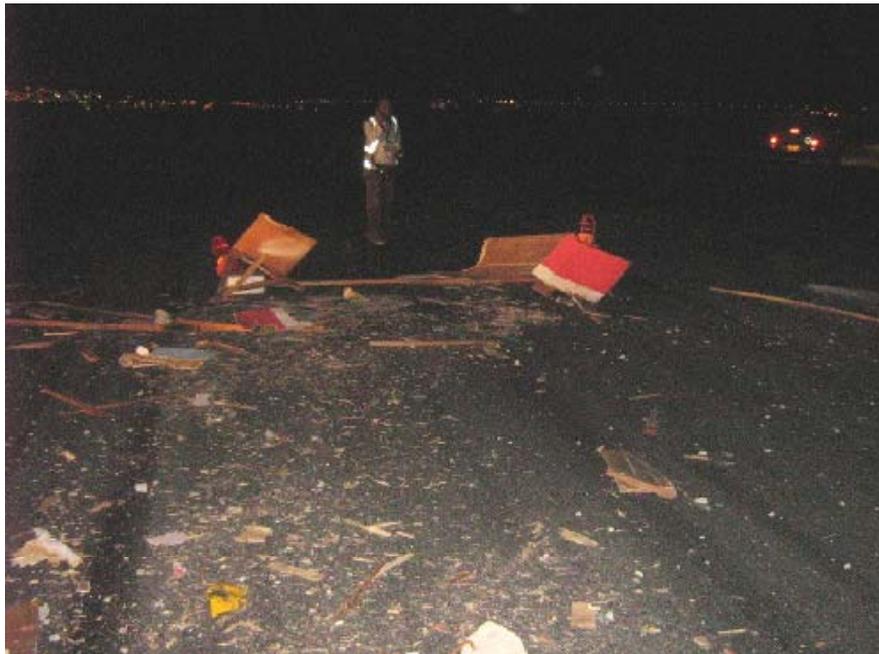
Figure 11: Damaged runway end marker board lights

During the takeoff, a group of workers were doing runway re-surfacing work at the end of runway 20C. The workers reported that when the aircraft flew overhead, it was low enough that their reaction was to squat down.
