GENERAL AVIATION (FAR 23) COCKPIT
STANDARDIZATION ANALYSIS

11 MARCH 1978

FINAL REPORT
July 76 - Jan 77

Prepared for
U.S. DEPARTMENT OF TRANSPORTATION
FEDERAL AVIATION ADMINISTRATION
Systems Research & Development Service
Washington, D.C. 20590

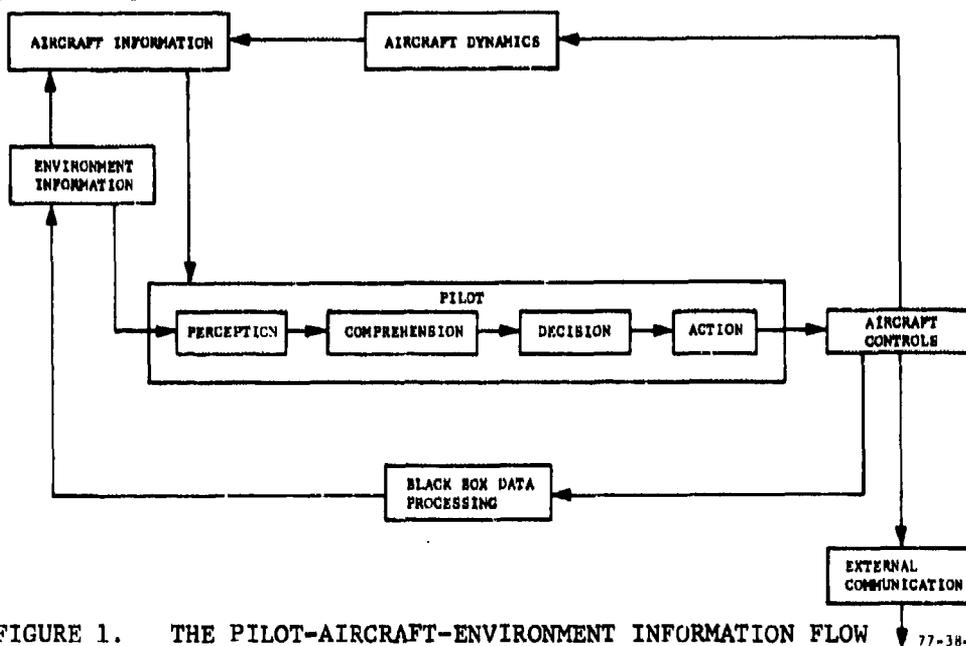
FIGURE 1. THE PILOT-AIRCRAFT-ENVIRONMENT INFORMATION FLOW 77-38-1

This study attempts to break the pilot-aircraft-environment causal chain at the point that the pilot effect is active in the cockpit. Examination of the stages of pilot-aircraft interaction in the cockpit may suggest a rational approach. Figure 1 illustrates a typical human factors loop of pilot information processing.

The pilot is engaged in the perception of information about his/her aircraft state, dynamics, and the environment. In order to take appropriate corrective action he/she must perceive and correctly comprehend a danger signal among less significant aircraft and environment information. The pilot may not sense the signal if it is not part of his/her audio or video field of recognition, or if it is otherwise blocked. Or he/she may perceive the signal but fail to comprehend its full meaning or critical significance. This failure could occur because the signals' strength or clarity does not facilitate discrimination from the general cockpit noise context or because the number and complexity of cockpit displays and tasks does not allow sufficient time for assessment of the relative significance of the symbol. Decision is the information processing phase in which the pilot selects from a repertory of alternatives the particular action that is appropriate. A danger signal may be perceived and its importance may be comprehended, but the correct action may not be elected. Finally, a failure may occur when the pilot implements the selected action. The physical action itself may be poorly coordinated or incorrectly performed.

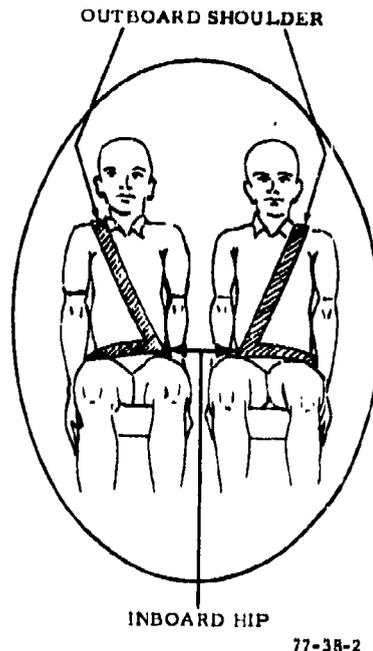
FIGURE 2. UPPER TORSO RESTRAINT INSTALLATION--DIAGONAL BELT

Ideally, the diagonal chest-type restraint anchor point is located on the outboard side of the cabin structure, behind the occupant's outboard shoulder. This anchor point then allows the upper torso restraint to pass over the outboard shoulder and fasten inboard at the occupant's hip as shown in figure 2. This arrangement is recommended to minimize body impact with the side structure of the aircraft cabin in the event of an emergency crash landing.

Aircraft structural design in at least one model precluded this anchor point arrangement because of the location of the doors. In this model, the anchor point for the upper torso restraint was located in the overhead behind and midway between the two front seats. This arrangement brings the upper torso restraint across the chest from the inboard shoulder to the outboard hip; while restricting forward body movement in the event of rapid deceleration, this configuration provides little, if any, protection for body and head impact in forward/sideward decelerations.

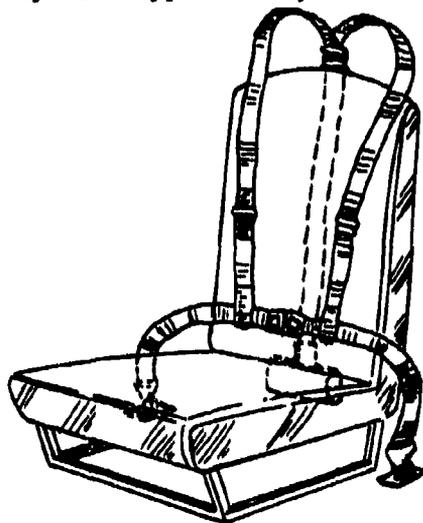
77-38-3
FIGURE 3. INTEGRAL RESTRAINT WITH DUAL BELTS

In the United Kingdom (UK), the combined efforts of two manufacturers of aircraft products resulted in the development and manufacture of an inertia-reel full harness which consists of two over-shoulder, integral restraints that cannot be unhooked to leave just the lap belts fitted. Both lap and shoulder straps are locked by a single clasp and are adjustable (figure 3).

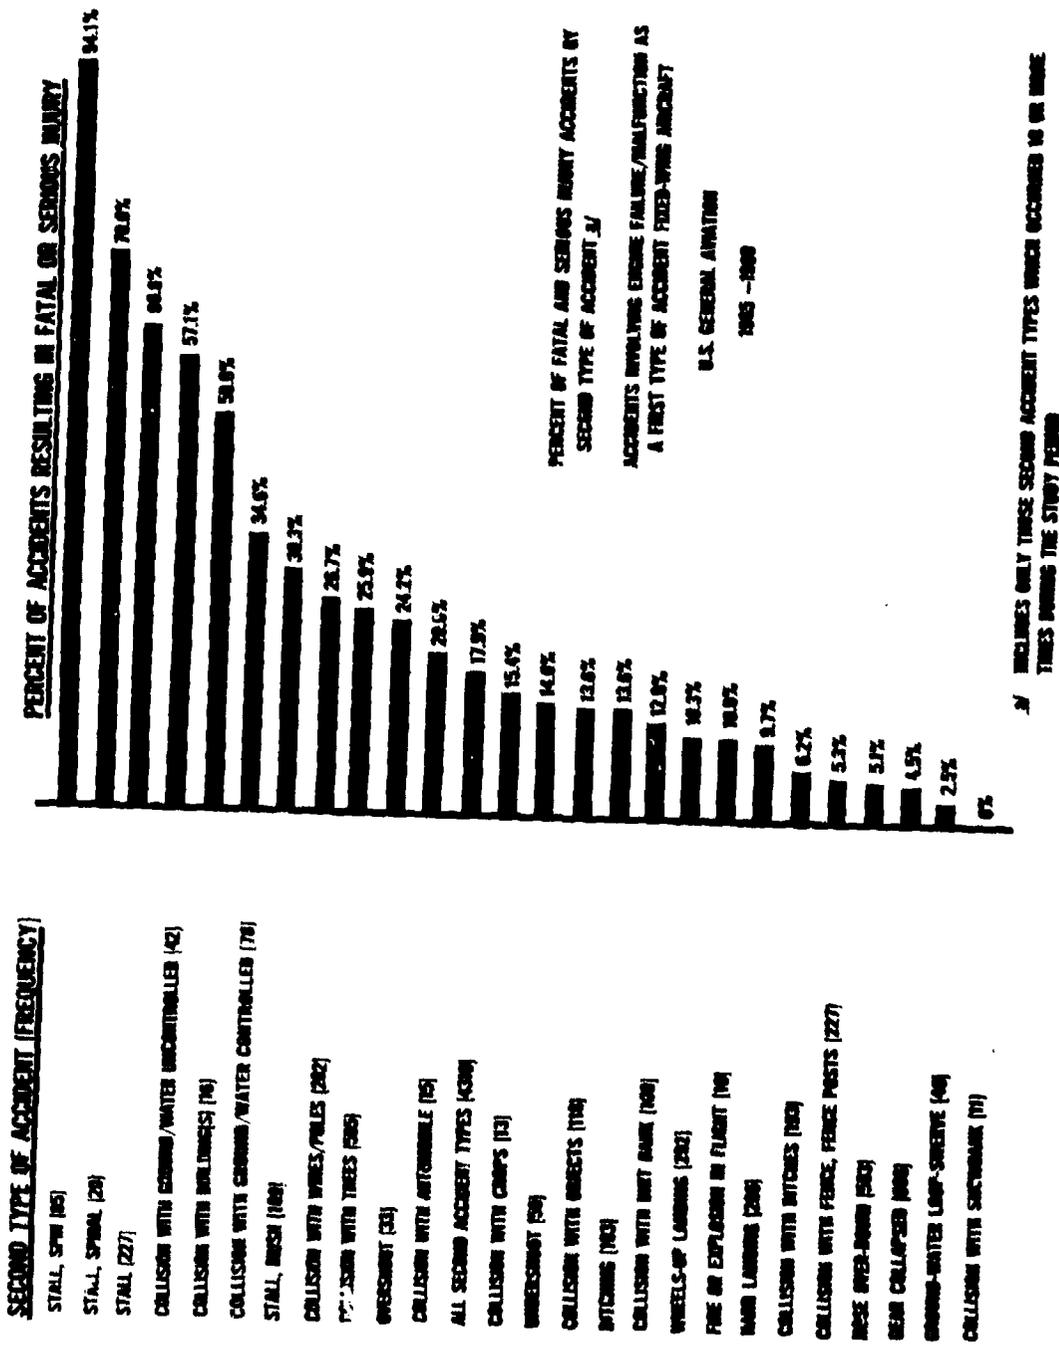
FIGURE 4. FREQUENCY OF SECOND-TYPE ACCIDENTS AS A RESULT OF ENGINE FAILURE

The NTSB accident data for the years 1970 through 1974 (table 1) show 4,954 engine failure accidents. Of this number, 683 (13 percent) were caused by improper operation of the powerplant controls. A summary report of general aviation accidents for the years 1973 and 1974 (reference 34) shows 167 accidents caused by misuse or failure to use carburetor heat, and 43 accidents attributed to misuse of the mixture control. Some examples of mixture control misuse are depicted in table A-6 of appendix A.

A review of NTSB accident data for improper use of powerplant controls (reference 28) indicates that the most common errors were: (1) pilots inadvertently pulling back the mixture control instead of the carburetor heat control, (2) pilots pulling back the mixture control instead of the propeller control, and (3) retarding propeller RPM control instead of the throttle. The first two pilot error actions can result in the complete cut-off of fuel to the engine with subsequent engine failure. The last action results in reduced propeller RPM with ensuing power loss. If the pilot fails to recognize the improper use of the powerplant controls, or does not have sufficient time or altitude to restart the engine, he is faced with a second type of accident situation, the first being engine failure due to powerplant control misuse. (Note: For an engine failure to be classified as an accident, the occurrence must be in combination with another or second-type accident.) The possible consequences of inadvertent, self-induced engine failure resulting in second-type accidents are depicted in figure 4. The data are for all general aviation operations for the years 1965 through 1969, and show the frequency and percent of accidents resulting in fatal or serious injury occurring from a second-type accident. The self-induced engine failure accident is neither isolated nor limited to the inexperienced pilot. The fact that it does occur with a low but regular frequency indicates the need for an amplification of powerplant control design standardization.

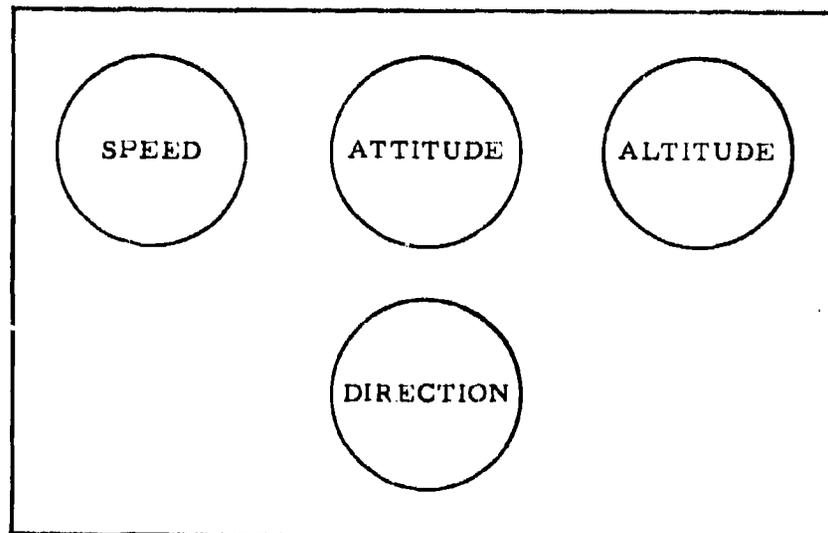
FIGURE 5. BASIC T FLIGHT INSTRUMENT PANEL ARRANGEMENT

Aircraft that have a maximum weight of 6,000 pounds or less are not required to have a standard arrangement of flight instruments on the instrument panel. For FAR 23 aircraft over 6,000 pounds, the four flight instruments which provide basic information on airspeed, attitude, altitude, and direction must be arranged as shown in figure 5 (FAR 23.1321, reference 1).

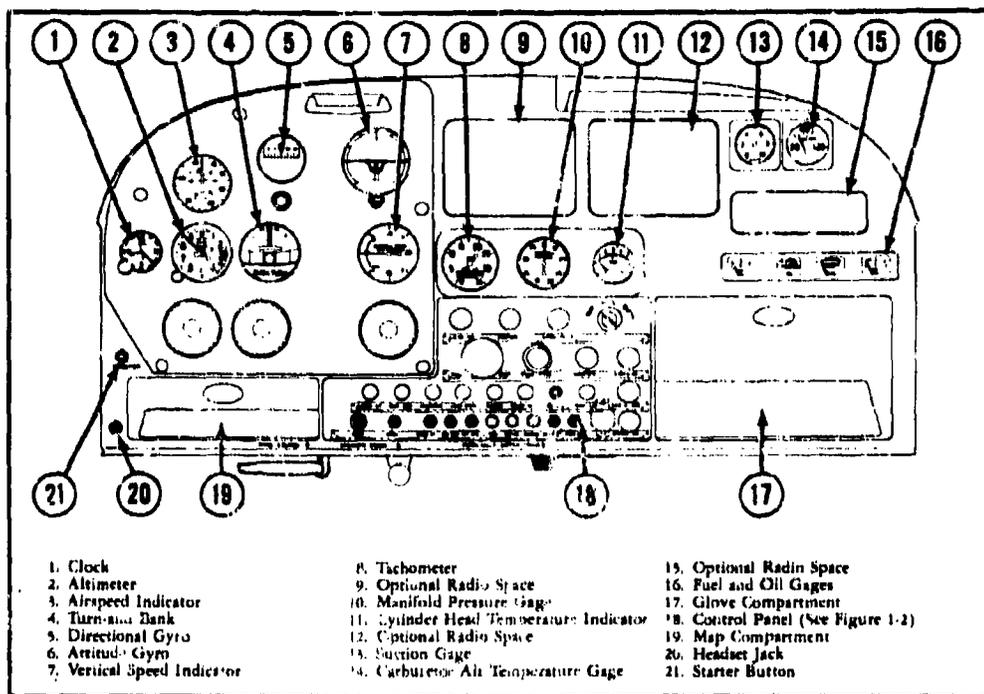
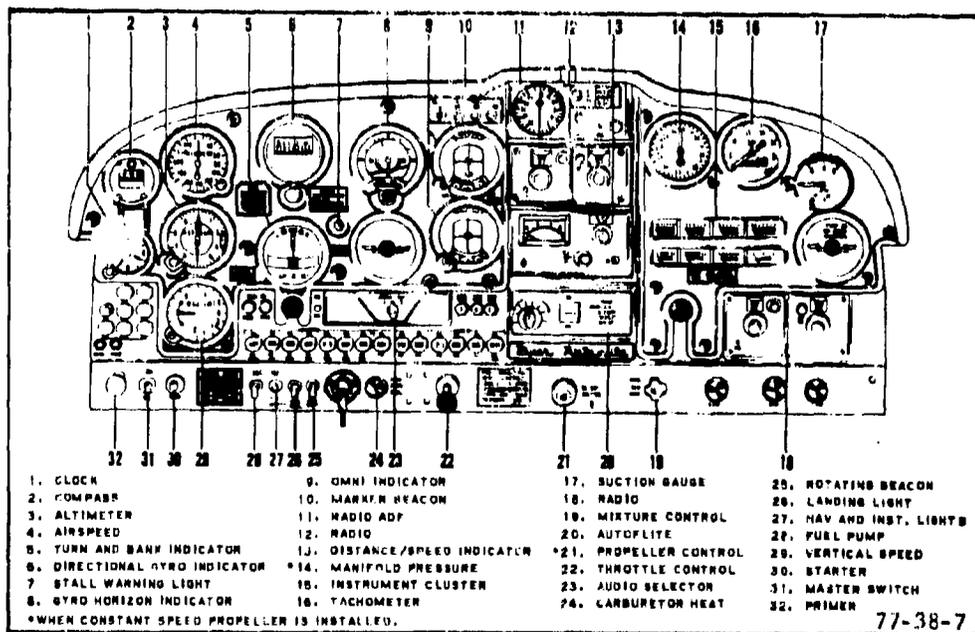
FIGURE 6. SAMPLES OF NONSTANDARDIZED INSTRUMENT PANEL

In 1965, NAFEC instrument flight pilot workload study (reference 36) revealed that the variations in panel arrangements were random and numerous. Examples of the diverse instrument layouts typical of that period are shown in figures 6, 7, and 8.

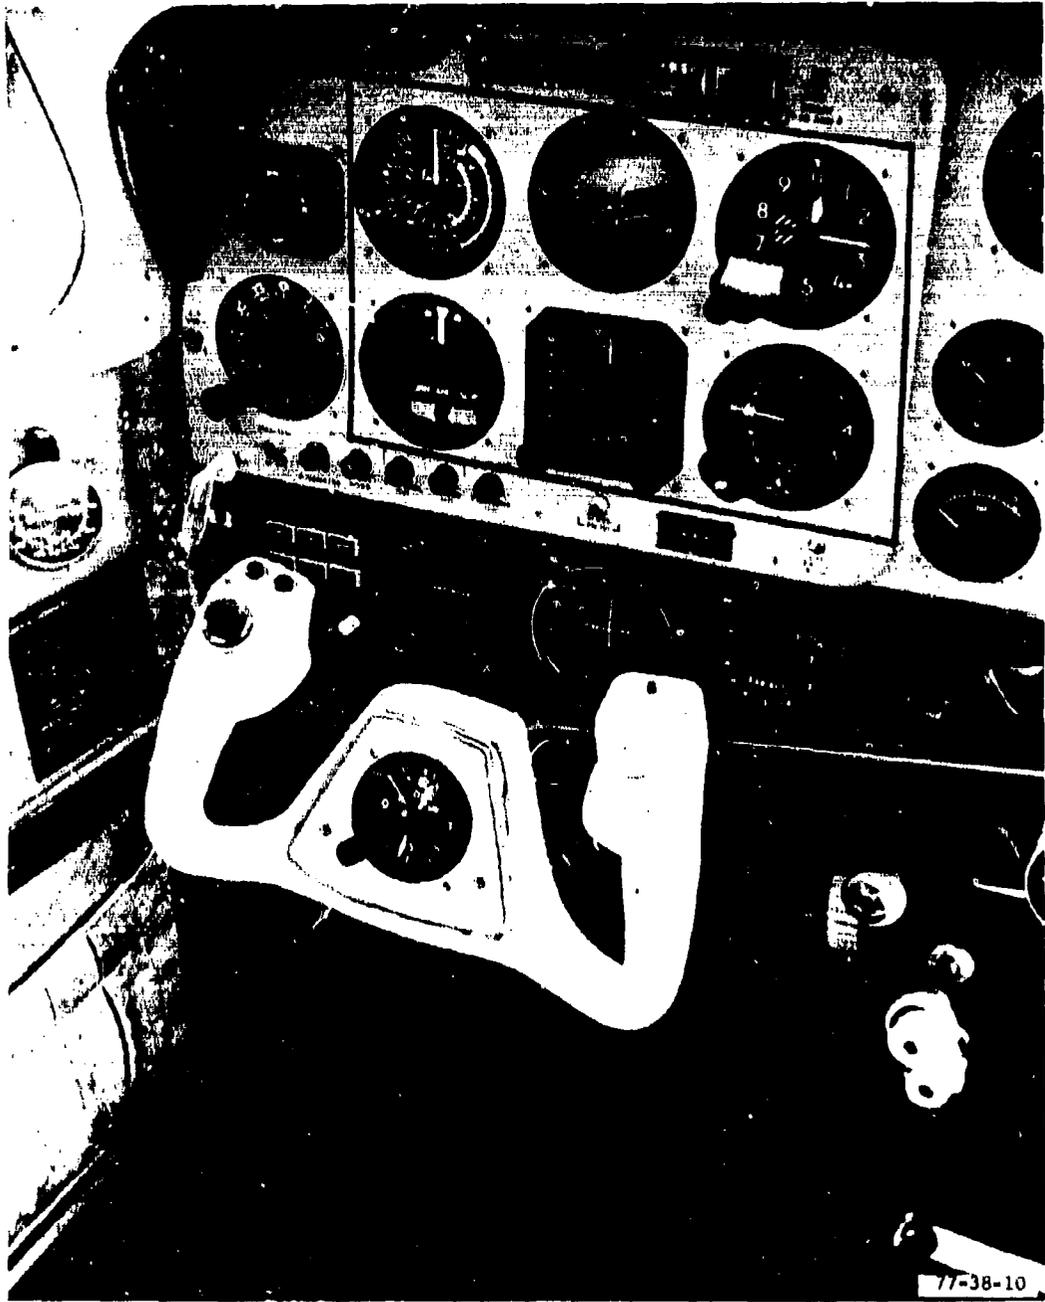
FIGURE 9. EXAMPLE OF A REVISED BASIC SIX INSTRUMENT CONFIGURATION

instruments comprising the T (airspeed, attitude, altitude, and direction), the location of the turn/slip indicator (turn coordinator) and the vertical speed indicator (VSI) has resulted in a "revised" Basic Six arrangement for late model FAR 23 aircraft. The configuration is shown in figure 9.

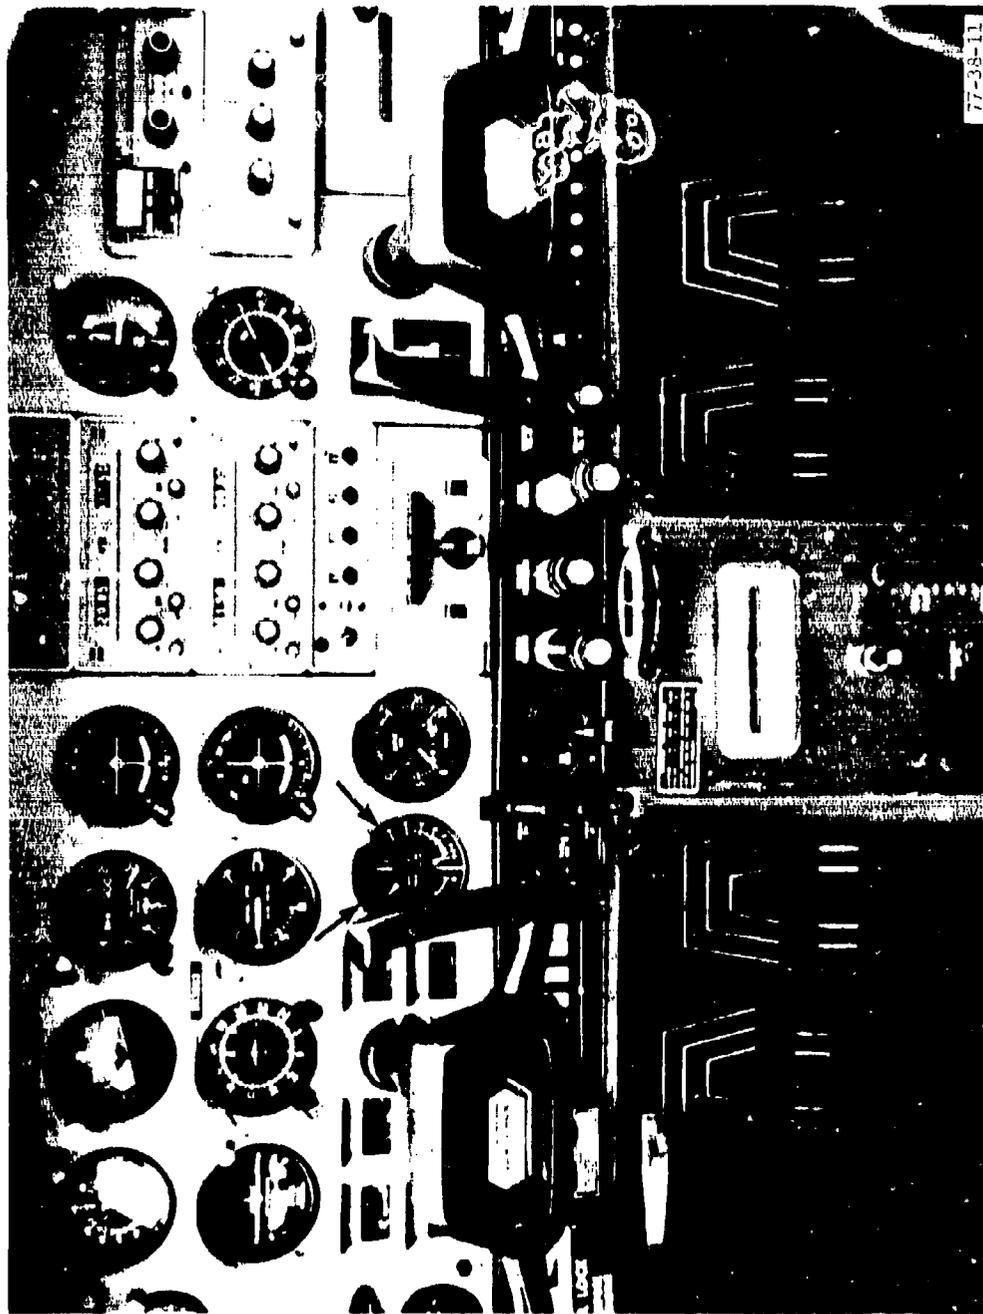
FIGURE 10. COMBINATION OF POWER PLAN INSTRUMENTS

panel does not allow for a desirable grouping or sequenced arrangement. A typical single-engine example is shown in figure 10. The manufacturer at times must position the powerplant instruments in a vertical line on the panel while the standard arrangement of the powerplant controls is a horizontal arrangement, either on the panel or on the powerplant control quadrant. Ideally, the manifold pressure gauge should be located on the panel in line with and above the throttle, the tachometer in line with and above the propeller control, and the fuel flow indicator in line with and above the mixture control. This arrangement is not always possible when, for example, the indications for manifold pressure and fuel flow are incorporated in one instrument (figure 10).

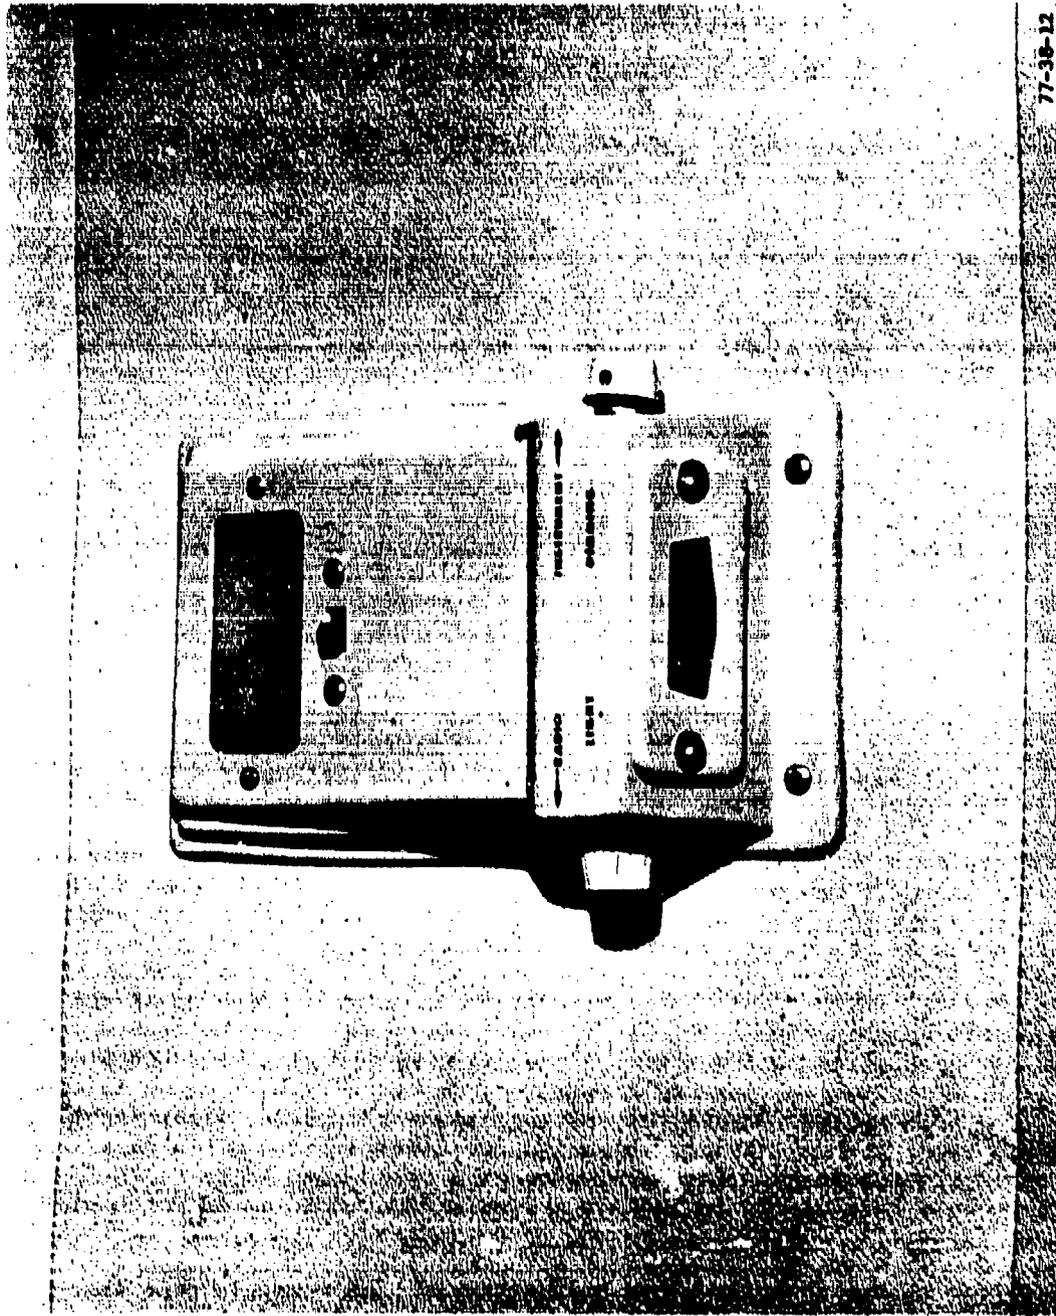
FIGURE 11. AIRCRAFT CABIN DOME LIGHT

There are four classes of systems used to light instruments and controls. The simplest is floodlighting, provided in the minimum system by a single red or white light on the cabin ceiling (figure 11). The second consists of eyebrow and post lights adjacent to the instruments. Integral lights, the third class, may spread light over instruments from locations just under the panel surface. The fourth type, transilluminated systems, may provide integral back lighting.

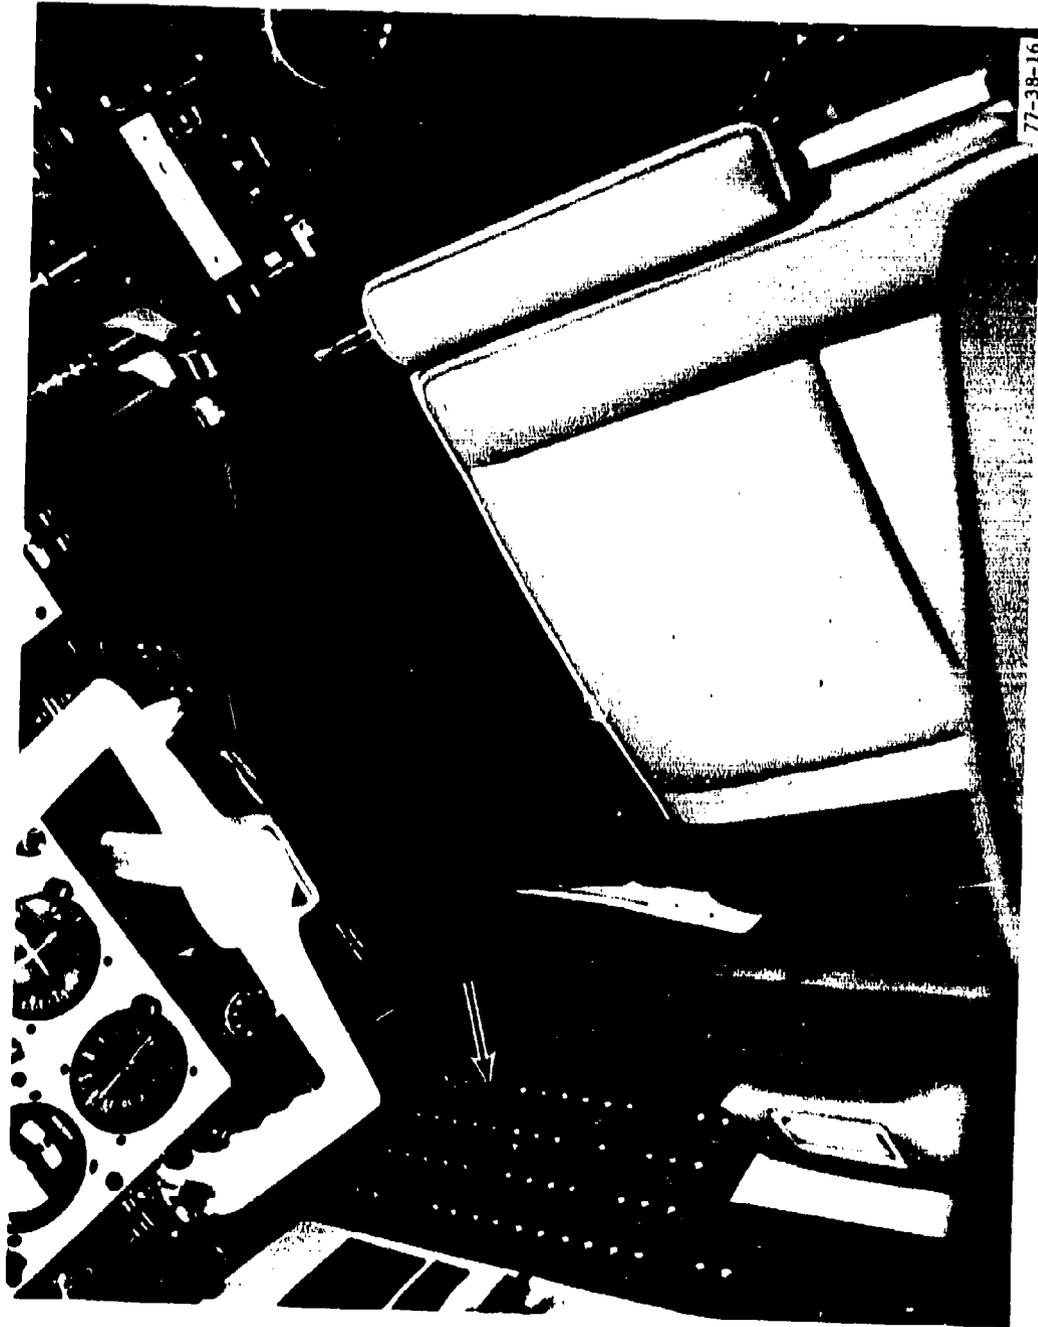
FIGURE 15. CIRCUIT BREAKER PANEL—MULTIENGINE AIRCRAFT

2. Circuit breakers should be easily identifiable and readily accessible to the pilot. Circuit breakers protecting critical circuits should be distinct and separated from those circuits protecting less critical systems. Standardized color coding is recommended.

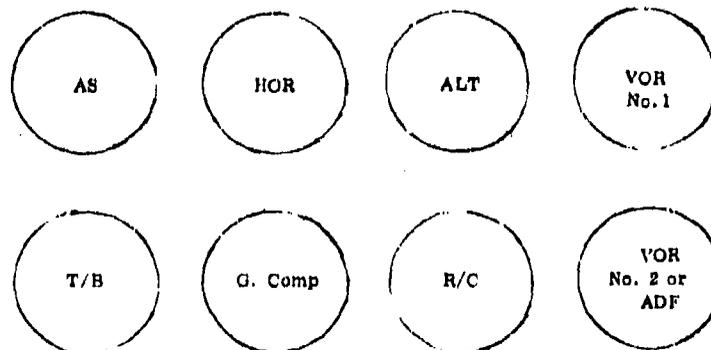
FIGURE 1

- 4.1 Figure 1 shows the general relationship of the flight and navigation indicators for one pilot aircraft or the Captain's position when two pilot position instrument panels are used.
- 4.2 When two instrument panels are used for two pilot aircraft the flight instruments for the copilot should use the same arrangement as the Captain's except that the VOR No. 1 and VOR No. 2 may be disregarded.
- 4.3 The No. 2 VOR position is the preferred position for the second VOR indicator. If only one VOR is used or if another navigation instrument is used nearly equally with the VOR, the indicator may be placed in the No. 2 VOR position.
- 4.4 An Instrument Landing System glide slope cross pointer, when used, should be incorporated into the VOR No. 1 position.

- 5.1 The gyro horizon or instrument that most effectively indicates attitude should be as near as possible to the top most position and as near as possible to the center of the pilot's position.
- 5.2 Other indicators should be located in the general position shown in Figure 1. It is not intended that they be placed in rigid horizontal and vertical lines (although it is preferred). The indicators should be in uniformly spaced groupings in front of the pilot position.

AS	Airspeed Indicator
HOR	Gyro Horizon Indicator
ALT	Pressure Altimeter
T/B	Turn and Bank (Slip) Indicator
G. Comp.	Gyro Compass
R/C	Rate of Climb Indicator
VOR	Course Deviation Indicator and Omni Bearing Selector

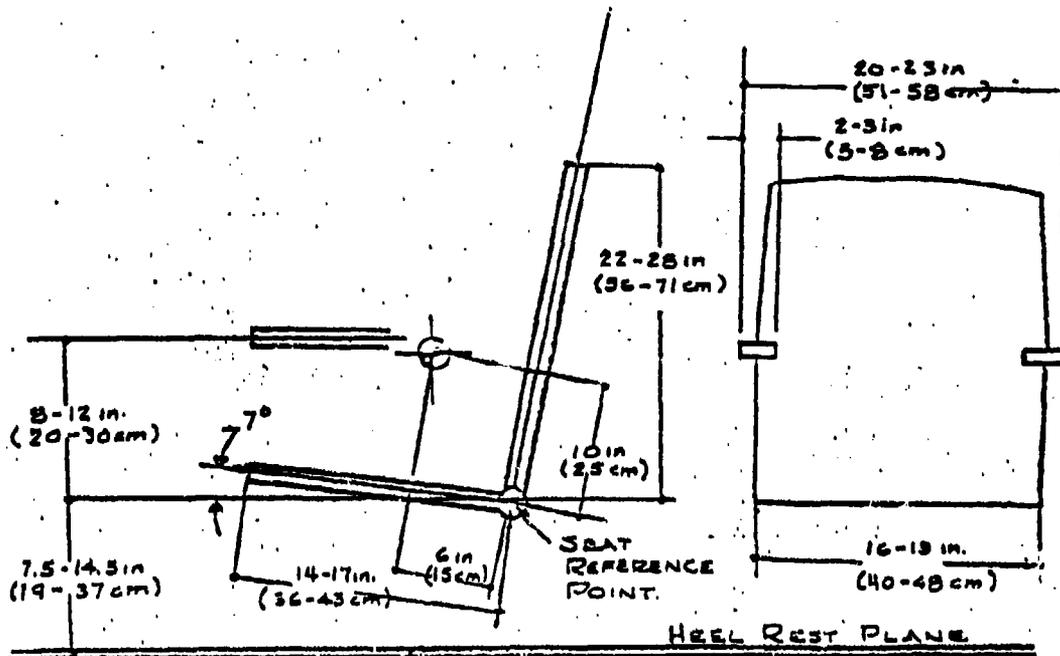
FIGURE 1
GENERAL AVIATION SEAT DIMENSIONS

- 4.1 Dimensions - The recommended ranges for seat dimensions are given in Figure 1. Illustrations are for dimensional purposes only and are not intended to fix the actual shape of the seat. It is understood that all dimensions influenced by passenger weight (i.e., cushion deflection) are to be measured under 1 g static loading with an occupant of standard weight.

- 4.6.1 Upper Torso Restraint - Seat-back height specifications of Figure 1 are based on considerations of protection, comfort and convenience. If the seat-back incorporates provision for shoulder harness attachment, the attachment position should be located above shoulder height or be designed so as to prevent the shoulder harness from imposing uncomfortable down loads under normal operating conditions. If attach point is located lower on the seat back, the seat-back should not fail under the specified dynamic conditions. (Refer to SAE ARP 1226, Occupant Restraint System (Active) for General Aviation Aircraft.)

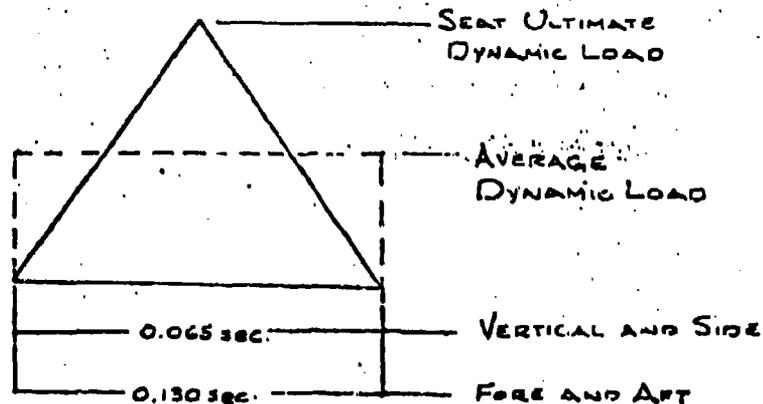
FIGURE 2
DYNAMIC LOAD PULSE SHAPE

- 4.4.2.1 A forward load of twenty-five (25) g's applied twenty (20) degrees to either side of the longitudinal axis, an aft load of 5 g's, an upward load of 15 g's and a downward load of 15 g's. Load directions should be determined with respect to the longitudinal axis of the airplane. The pulse shapes and durations for the above loads are specified in Figure 2. Load factors should be measured at the seat tracks or on the corresponding air-frame support structure.

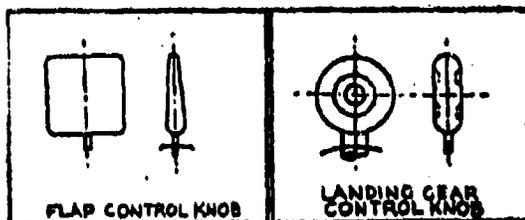
Cockpit control knobs must conform to the general shapes and color (but not necessarily to the exact sizes or specific proportions) as shown in the following figures:

QUADRANT MTD		PANEL MTD		BASIC COLOR
				BLACK
THROTTLE CONTROL KNOB				
				BLUE
RPM CONTROL KNOB				
				RED
MIXTURE CONTROL KNOB				
				GREY
CARB HEAT OR ALT AIR CONTROL KNOB				
				BLACK
SUPERCHARGER CONTROL KNOB
